MISSISSIPPI-SALT-QUINCY RIVER BASIN

EHRlich LAKE DAM
MONTGOMERY COUNTY, MISSOURI
MO. 10993

**PHASE I INSPECTION REPORT
NATIONAL DAM SAFETY PROGRAM**

DECEMBER 1980

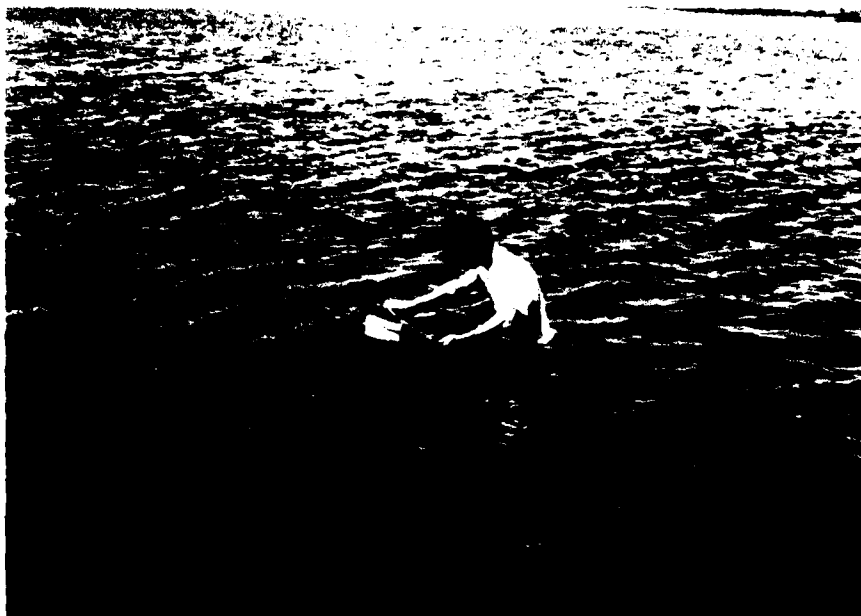
Photo 5

The trashrack provided for the spillway appears to be functioning the way it was intended. On the day of the inspection, some debris was observed on the top of the trashrack (see Photo 5). The trashrack, however, did not appear to be securely attached to the drop inlet. The spillway pipes do not appear to be obstructed due to the fact that the reservoir level on the day of the inspection was slightly above the spillway crest and water was observed discharging from the outlet end of the pipe. No seepage was ob-

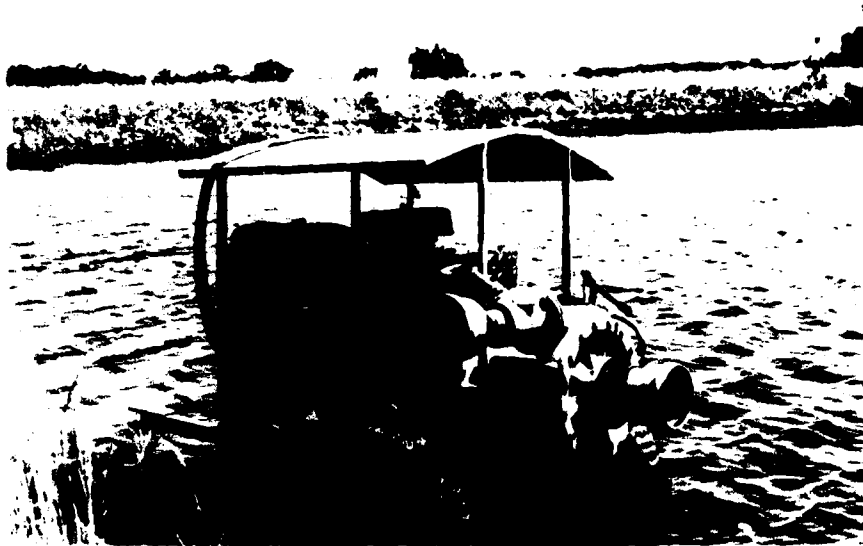
Photo 11

No low level outlets or outlet works were provided for this dam. However, a portable, gasoline powered, 18-inch, centrifugal pump is used at the damsite (see Photo 11). The pump is used to pump water from the reservoir to be used to irrigate row crops on the reservoir rim. The pump is used only when irrigation water is required and is generally used during the summer months.

There are no operating facilities associated with this dam, except for the portable, centrifugal pump used at the site. The pump was located on the left side of the reservoir on the day of the inspection and is operable, according to Mr. Ehrlich.
